Appendix II The M-105 and M-107

What Went Wrong With the M-107?

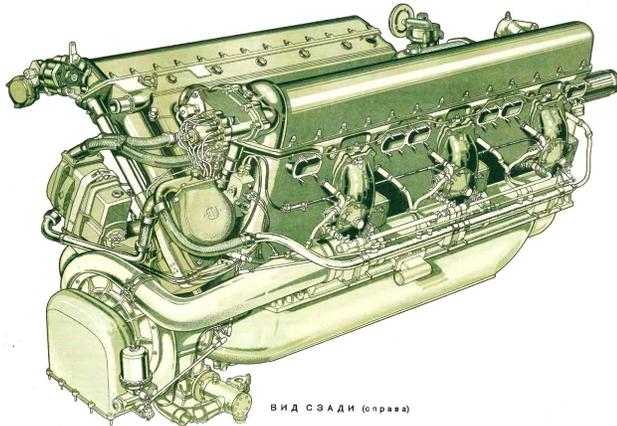
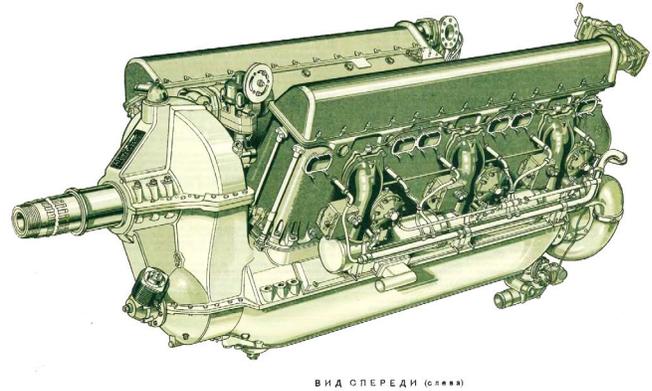
▲ Two superb illustrations of the M-105PF from the Yak-1 Album of Technical Drawings.

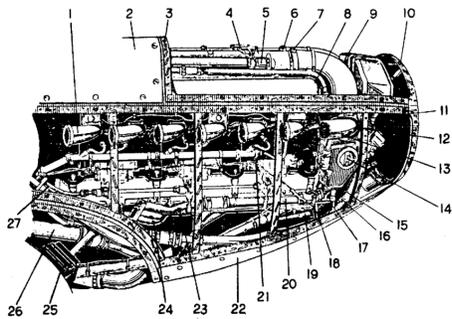
◀ The installation of the M-107A from the Yak-9P *Tekhnicheskoe Opisane*.

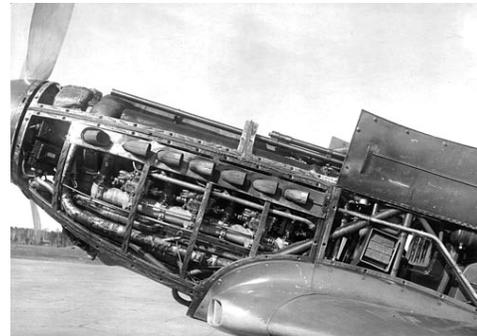
▶ M-107A installation in the Yak-9U, 1944.
